**PERFORMANCE
OF
FLOODWATER RETARDING STRUCTURES
NEAR MCKINNEY, TEXAS
DURING
STORM OF SEPTEMBER 20 - 21, 1964**

Prepared by
U.S. DEPARTMENT OF AGRICULTURE
SOIL CONSERVATION SERVICE
Temple, Texas
August 1969

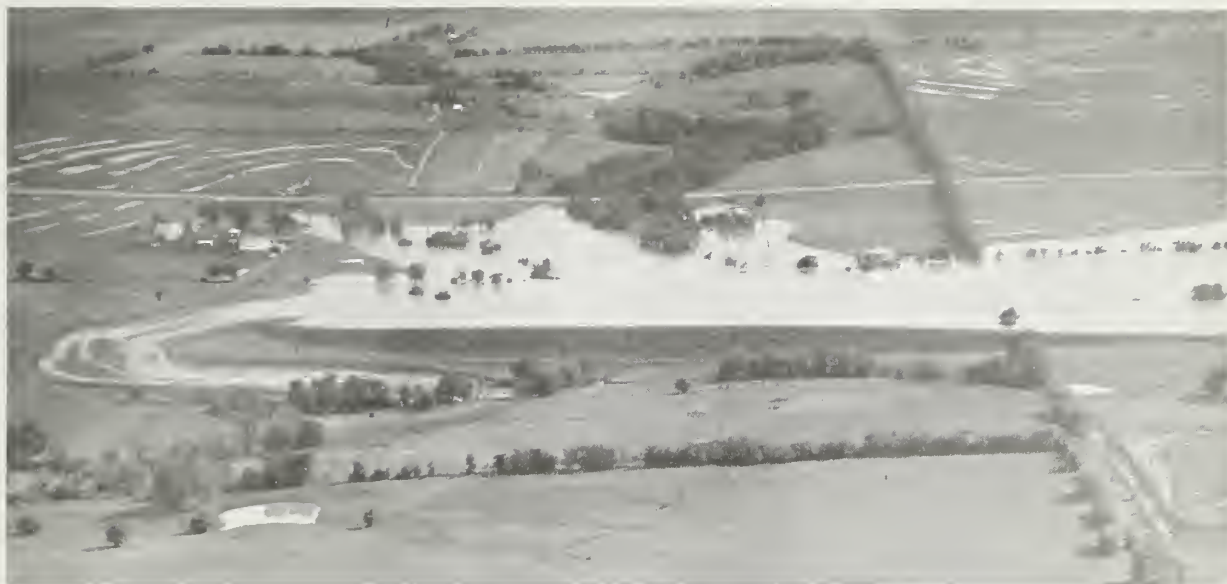
Floodwater detention and functioning of emergency spillway at Structure 2A, East Fork Above Lavon Watershed, after the storm of September 20-21, 1964.

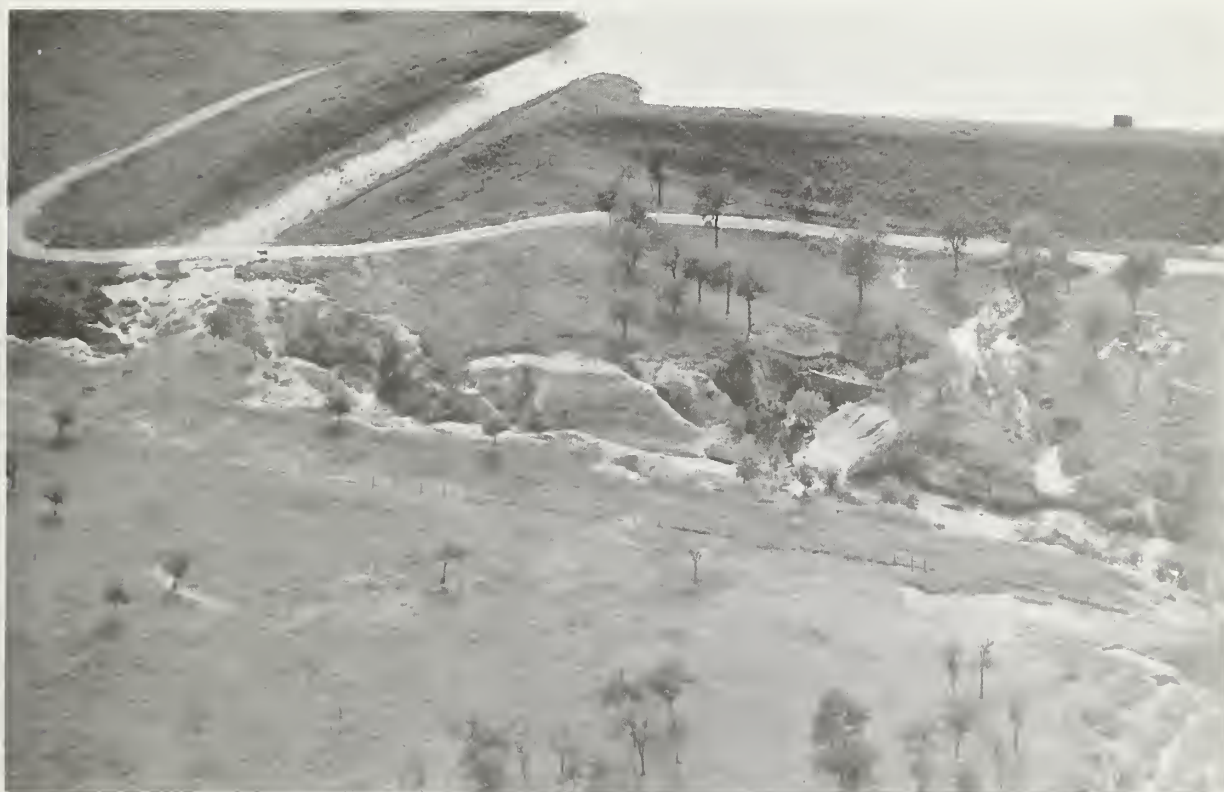
Emergency spillway flow at Structure 3A, East Fork Above Lavon Watershed, after the storm of September 20-21, 1964.

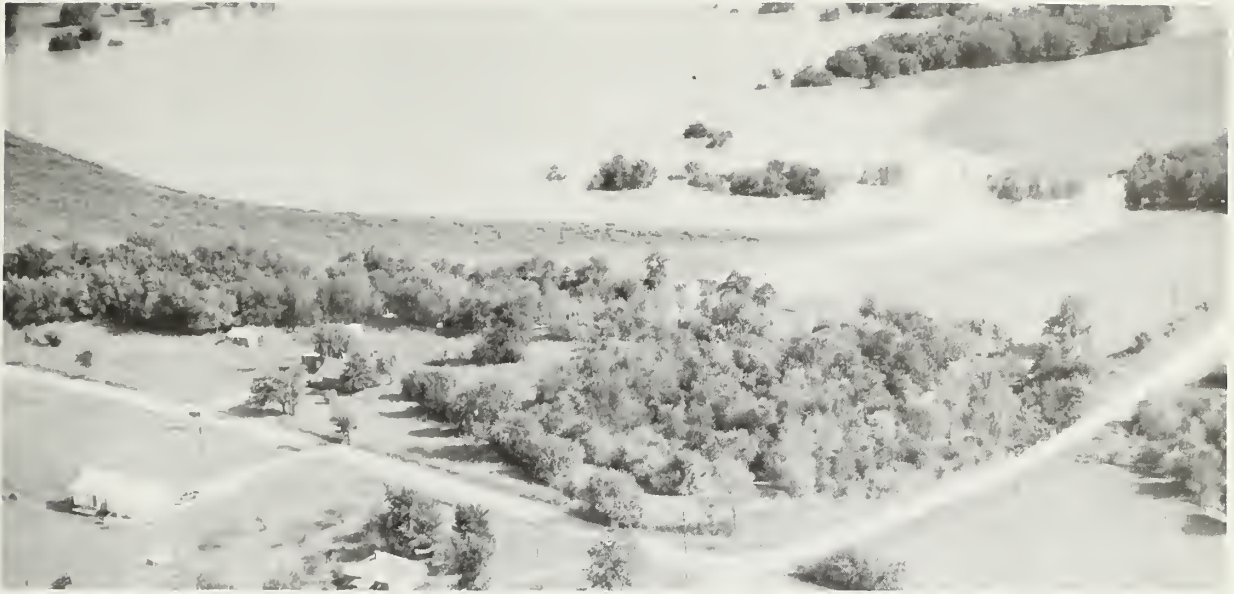
Structure 3C had slight damage to the emergency spillway. The fractured limestone overfall into the creek moved up the spillway exit channel approximately 20 feet. No repairs were needed.

Floodwater detention and emergency spillway flow at Structure 3C, East Fork Above Lavon Watershed, after the storm of September 20-21, 1964.
